2013 Annual Inspection Report

Fritchie Marsh Restoration

State Project Number PO-06
Priority Project List 2

May 15, 2013
St. Tammany Parish

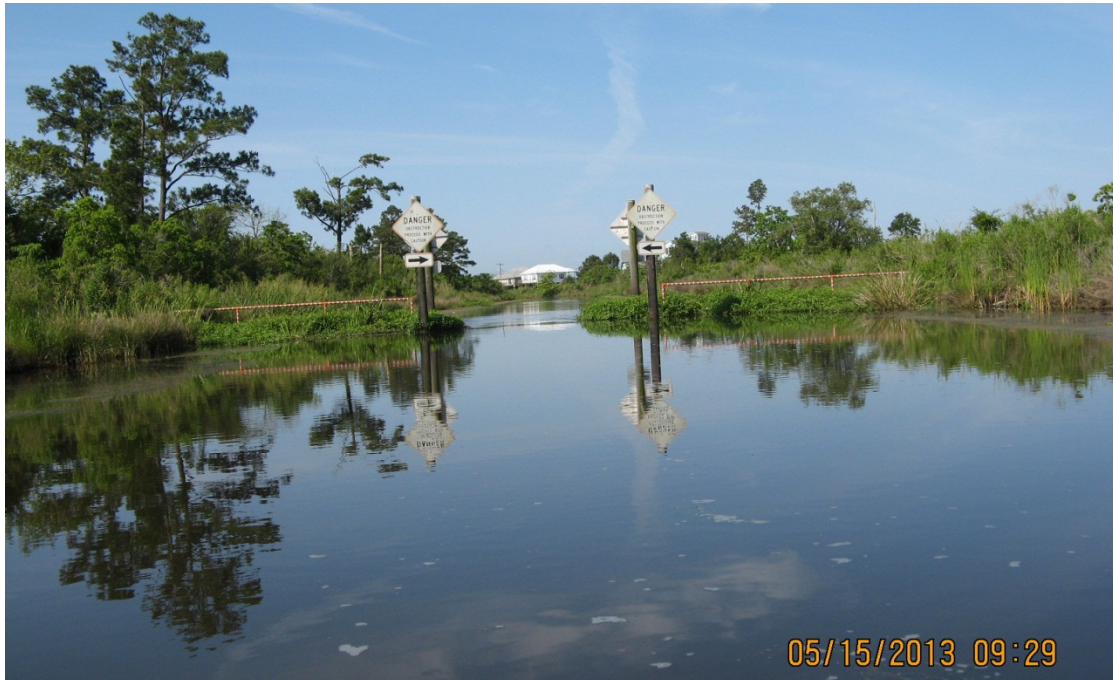
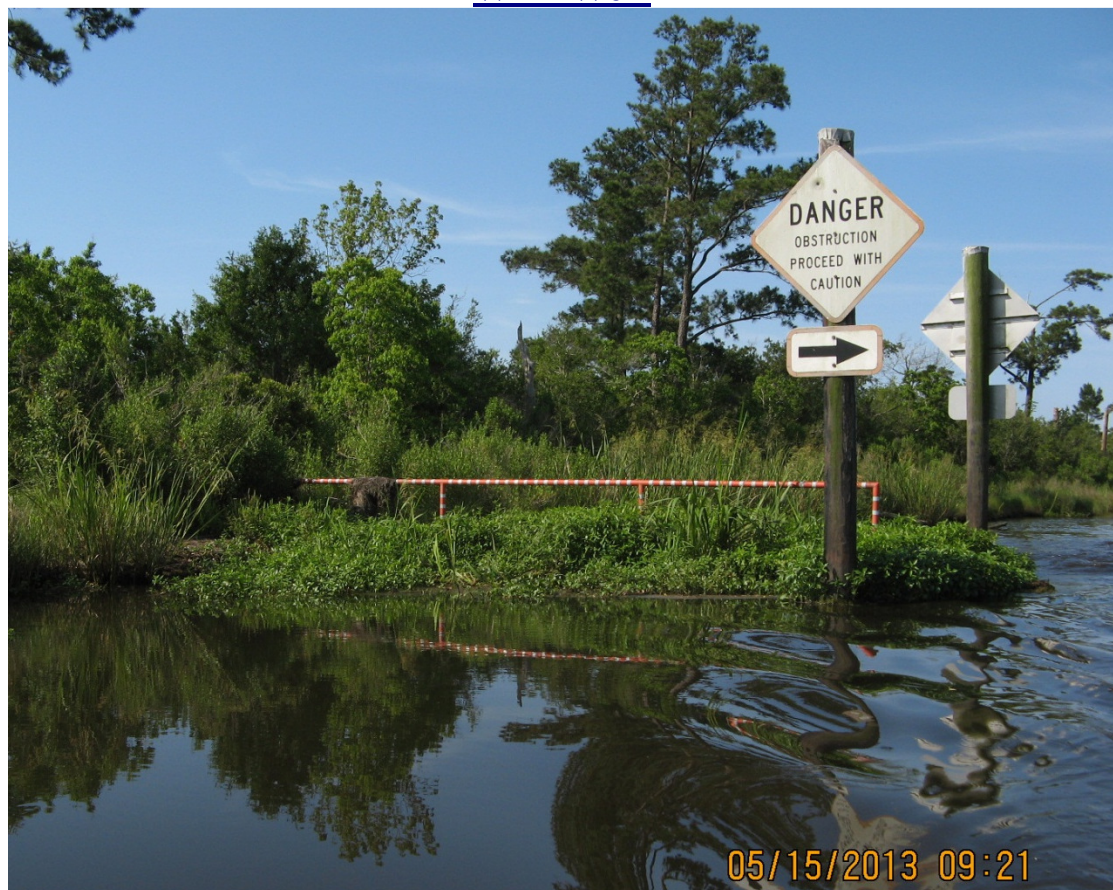
W-14 Weir

There was no visible damage to this structure or the signs. It is operating as designed.

Continue to inspect the project features for functionality. The project budget calls for sign replacement at Year 14 or 2016. The project team will determine the necessity of such replacement.

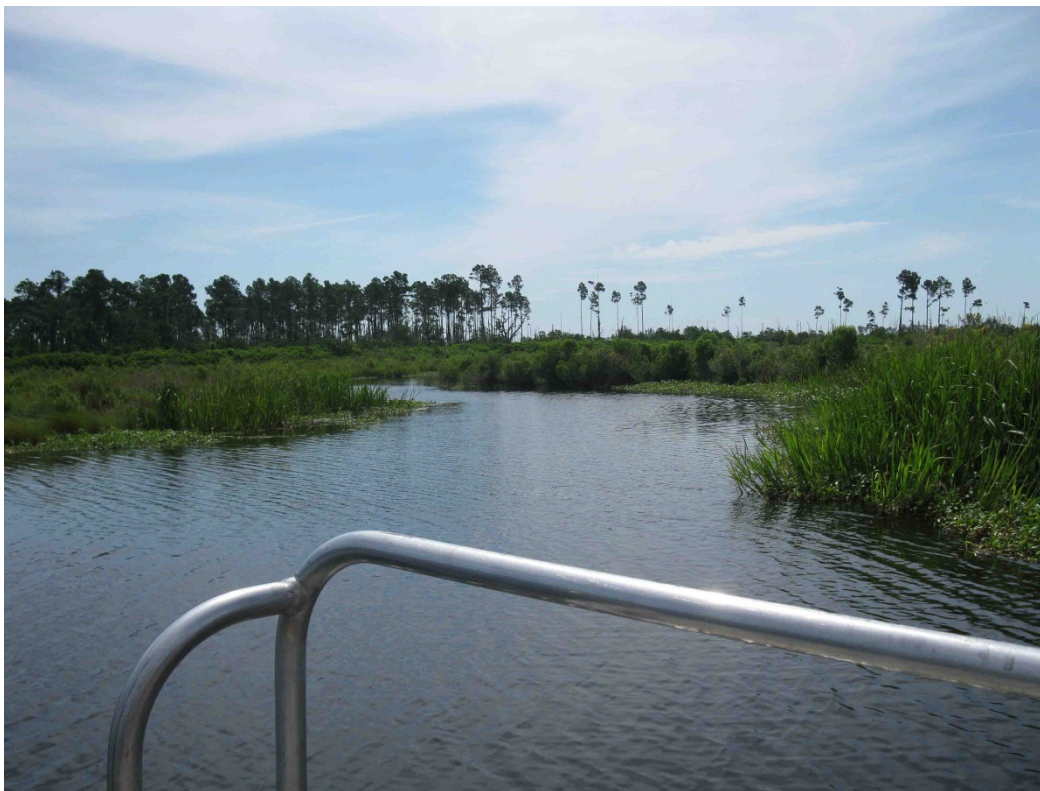
W-14 Diversion Channel Beyond Dredging

There is no visible change to this feature. Water is flowing through as designed.

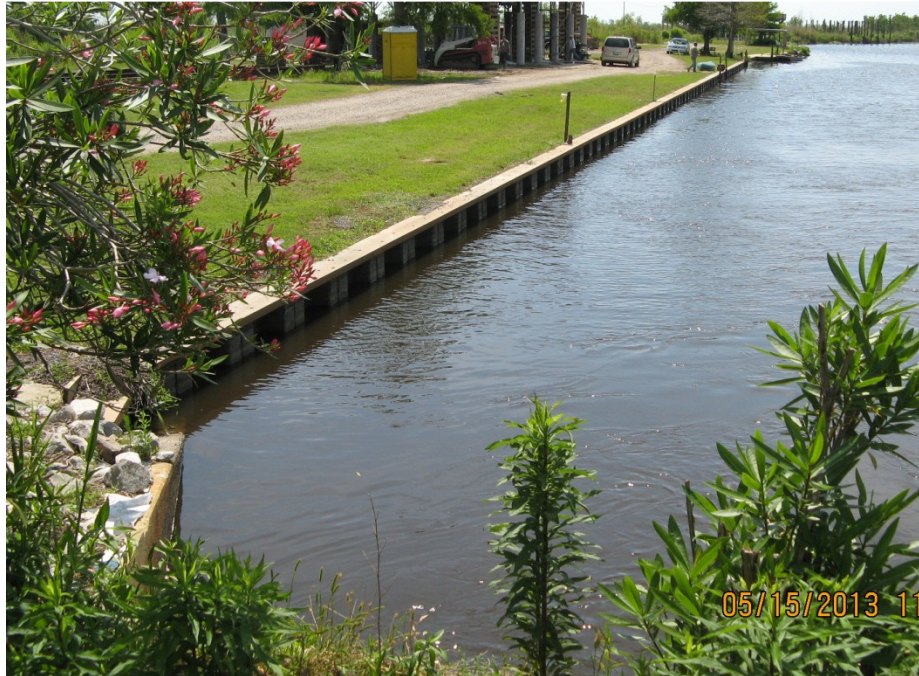
Bulkhead from East side of Hwy 90

Item	Condition	Physical Damage	Corrosion	Observations and Remarks
Steel Bulkhead / Caps	Good	None	None	Good
Handrails, Grating, Hardware, etc.	Good	None	None	Vegetation and debris surrounding railings. Overall condition is good.
Signage, Supports	Good	None	None	Clear and legible. Reflective tape fading
Rock RipRap channel lining	Good	None	None	
W-14 Weir structure	Good	None	None	Submerged. Water flowing
W-14 diversion channel dredge	Good	n/a	n/a	Debris at inlet of channel
Salt Bayou dredging	n/a	n/a	n/a	Inspection halted approximately 1.3 miles from Hwy 0 to due shallow water levels in Salt Bayou. Branches and fallen debris in channel at culvert outlet
72" Diameter culvert	Good	None	None	Functioning properly. No undermining of the structure observed.
HWY 90 road surface	Good	None	None	Asphalt layer appears to have been ground down recently. Cracks exist.
